Stillaguamish Tribe FY11 PSP Final Report

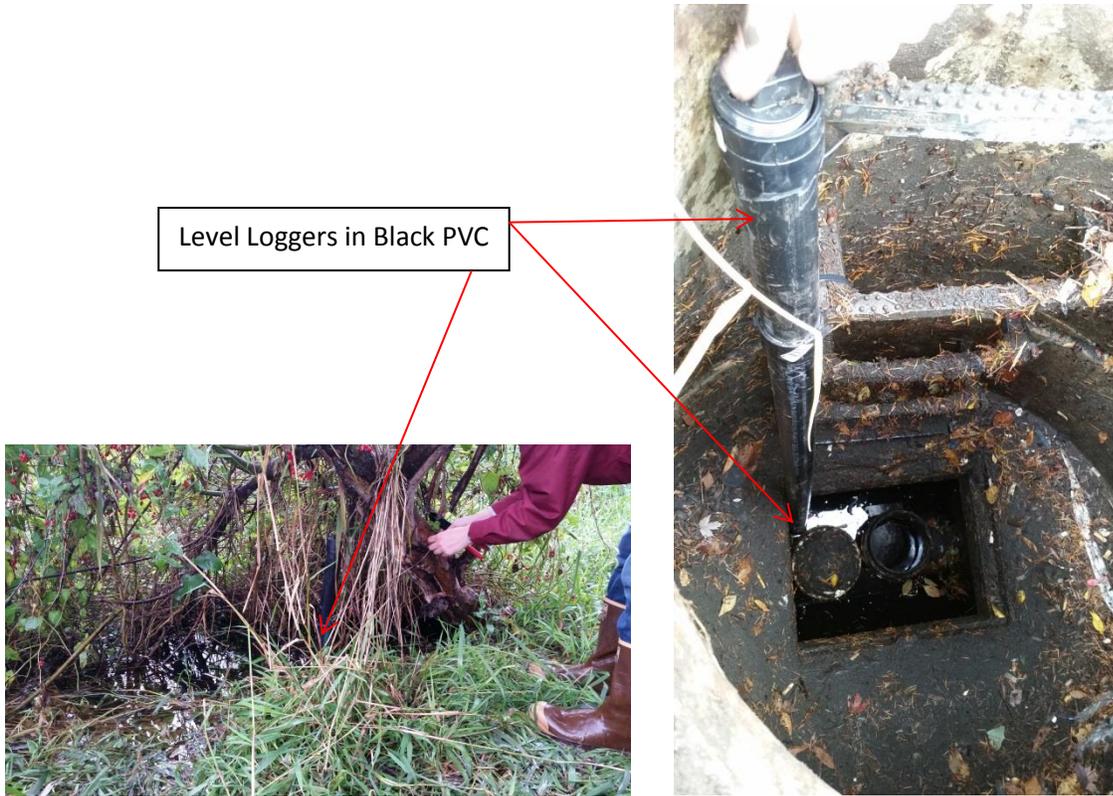
Figure 1a. Level logger in Portage Creek.

Figure 1b. Level loggers in Infiltration Trench.

We placed three HOBO® U20 Water Level Loggers in the project area to determine water levels in the infiltration trench during rain events, and to determine how those levels would impact delivery to Portage Creek. As a result, one logger was placed in Portage Creek (Figure 1a) and two were placed in the manhole that provided access to the infiltration trench (Figure 1b). Of the two in the manhole, one was placed at the bottom to measure water level above it. The other was used to measure ambient air pressure in order to subtract it out from water level.
